Janzen Brothers Farms

Livestock Producer *Environmental Assistance Project*
Minimizing risk for small, environmentally conscientious livestock producers.

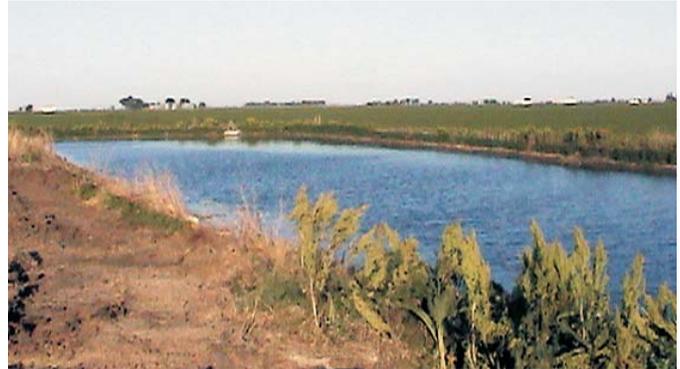
Before project

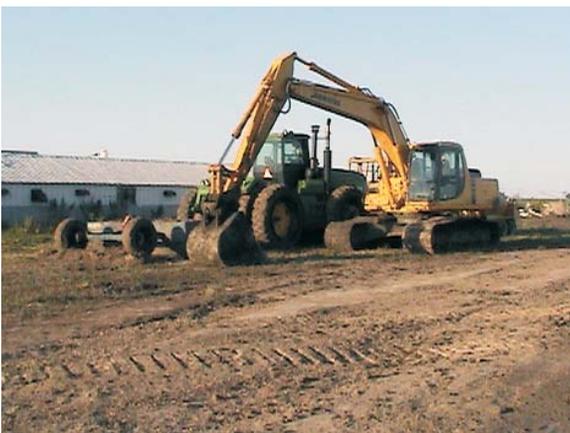
During construction

After the sludge was removed and stock piled, the lagoon was ready to be filled in. The embankments of the lagoon were pushed in and the land area graded back to original slope. There was some over-fill to allow for settlement and for the area to drain. The land area was converted back to a crop field.

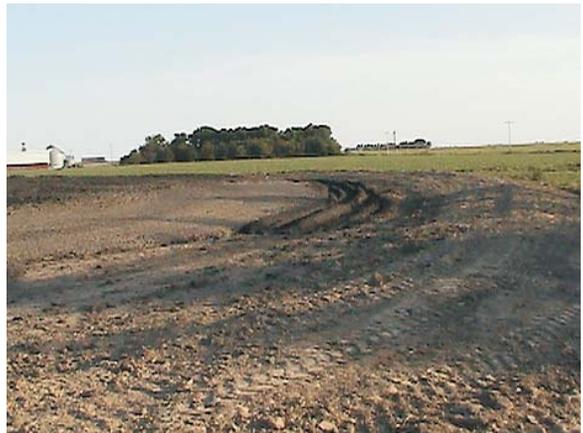
Stock pile

The sludge in the lagoon and crop field soils was sampled and the sludge application rate was calculated to apply a five-year supply of P_2O_5 for irrigated corn. The liquid and slurry portion of the lagoon was agitated, pumped, and applied to a nearby corn field. After the liquid portion was applied, the remaining solid sludge in the bottom of the lagoon was excavated out of the lagoon using an excavator. There was no compacted clay liner in the lagoon. The lagoon was over-excavated several feet below the constructed base to remove the contaminated soil, and contact clean soil. The solids were stock piled at a safe location on a field edge to be applied to the crop field at a more appropriate time. A storage terrace was constructed around the stock pile to exclude any runoff from contacting the stock pile. The lagoon held about 7,000 cubic yards of solid sludge. [what did they do with the contaminated soil?]
