# Kyes Swine Lagoon Abandonment

- Lagoon Abandonment

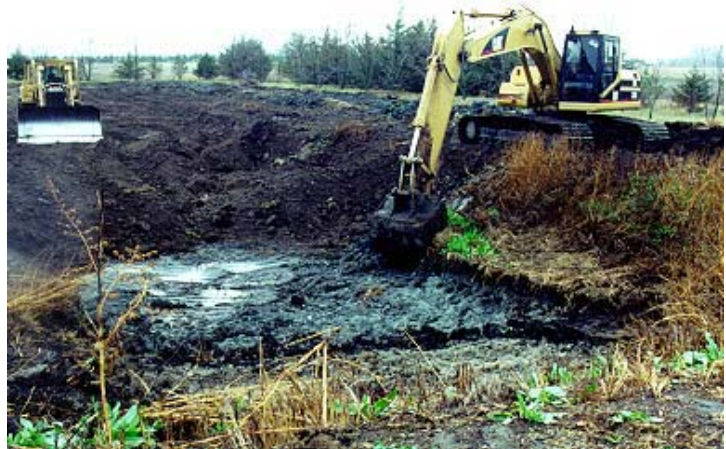
This lagoon was originally used for a swine finishing floor operation but had not been in production for the past 5 years. The cooperators wanted to decommission the lagoon.

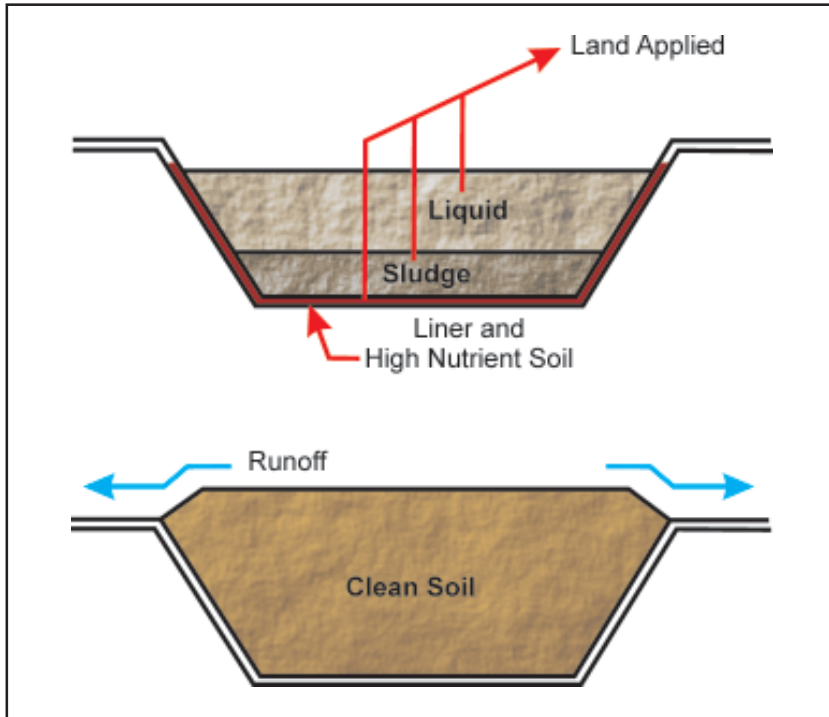
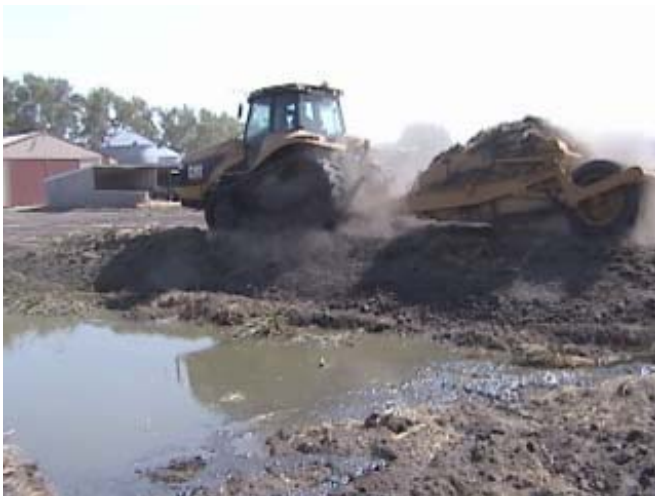
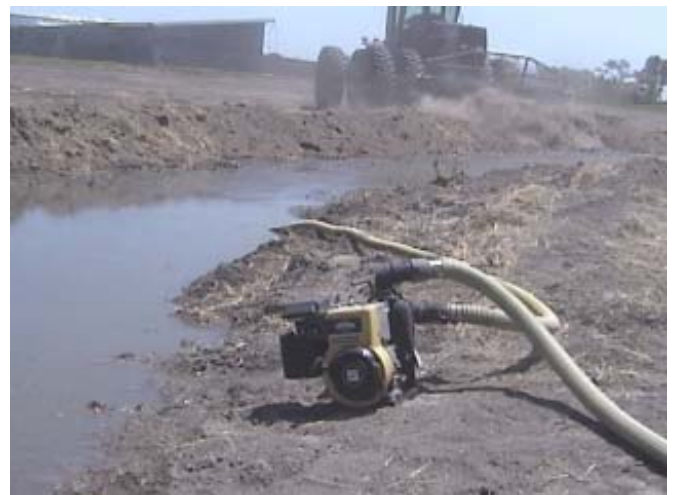
The structure was closed by pushing in the existing berms and bringing in additional fill dirt as needed. The area was crowned for rapid moisture movement away from the covered structure. After the dirt work was completed and the crown formed, a vegetative cover was established. Nutrients in the liquid and sludge were removed from the site and spread to cropland where they will be utilized and removed by the crop.
