# Dittmer Farms, Inc.

**Size:**  
**1000 Swine Feeder to Finish**

Livestock Producer Environmental Assistance Project  
Minimizing risk for small, environmentally conscientious livestock producers.

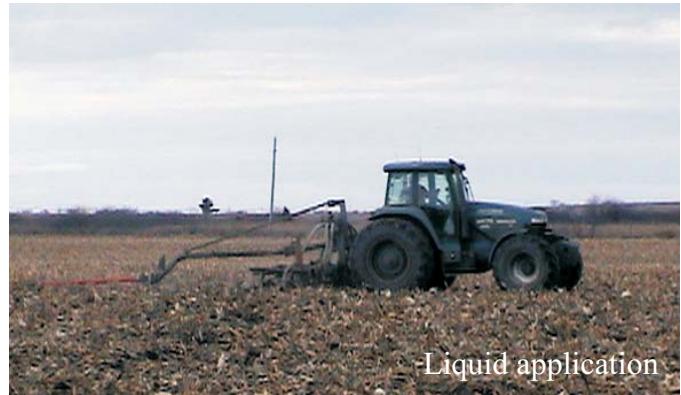
Liquid application

The sludge in the lagoon and crop field soils was sampled and the sludge application rate was calculated to apply a five-year supply of P<sub>2</sub>O<sub>5</sub> for irrigated corn. The liquid and slurry portions of the lagoon were agitated, pumped, and applied to a nearby corn field. After the liquid portion was applied, the remaining solid sludge in the bottom of the lagoon was then excavated out of the lagoon with a dozer and excavator. Care was taken to not disturb the compacted clay liner in the lagoon while the solids were removed. The solids were stock piled at a safe location on a field edge to be applied to the crop field at a more appropriate time. The lagoon held about 74,000 cubic feet of liquid sludge and 2,500 cubic yards of solid sludge.

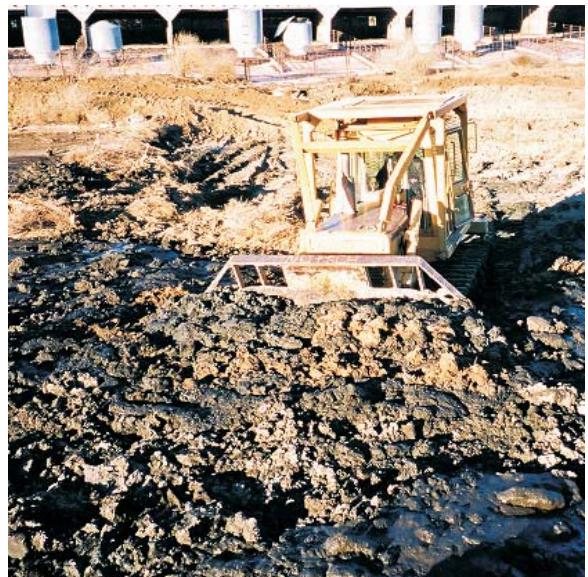
During construction

After the sludge was removed and stock piled, the lagoon was ready to be filled in. The embankments of the lagoon were pushed in and the land area graded back to original slope. There was some over fill to allow for settlement and for the area to drain. Since the buildings and concrete were left intact, a diversion was constructed to route any runoff water away from the old lagoon site. The land area was then planted to native grass to help control erosion.

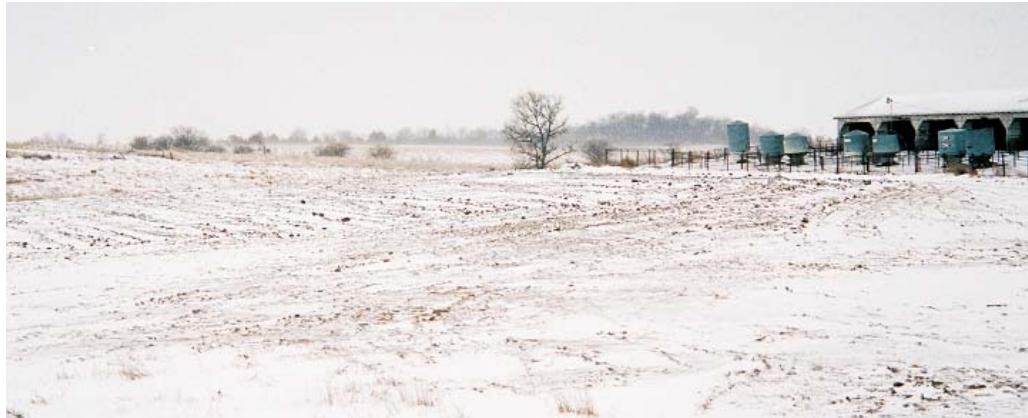
Completed project
