Arnold Kaslon

Size:
**35 sow farrow to finish
confinement**

- ◆ Lagoon Abandonment
- ◆ Sludge/Manure Land Application
- ◆ Wetland Habitat Development

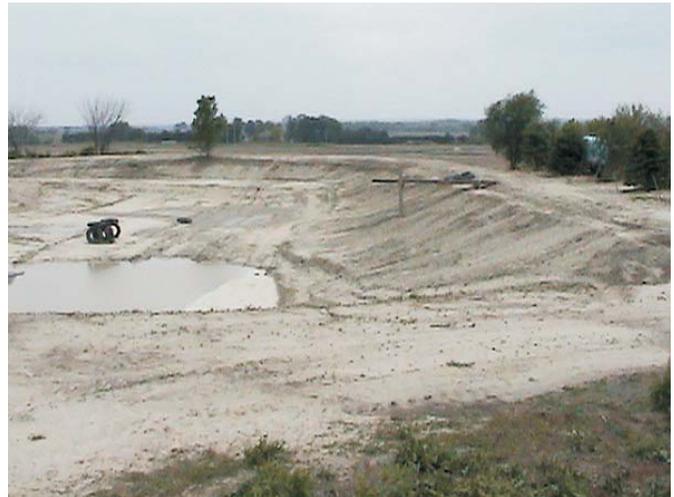
Wetland after construction

The lagoon was over-excavated to minimize the contamination of fresh water with phosphorous and nitrogen. The lagoon's top width and length were increased. For safety, the end slopes were flattened to a 6:1 slope to allow a person an easy exit. A berm was constructed around the wetland to prevent runoff drainage from the crop field entering the wetland. A fresh water inlet pipe from a ground water well was installed to maintain the water level, and an emergency corrugated metal pipe spillway was installed. Once filled, the water was tested for dissolved oxygen and ammonia to make sure the water would be suitable for fish. Once the water was safe, fish were released. Mr. Kaslon has been adding annual treatments of barley straw to help prevent algae growth in the pond.

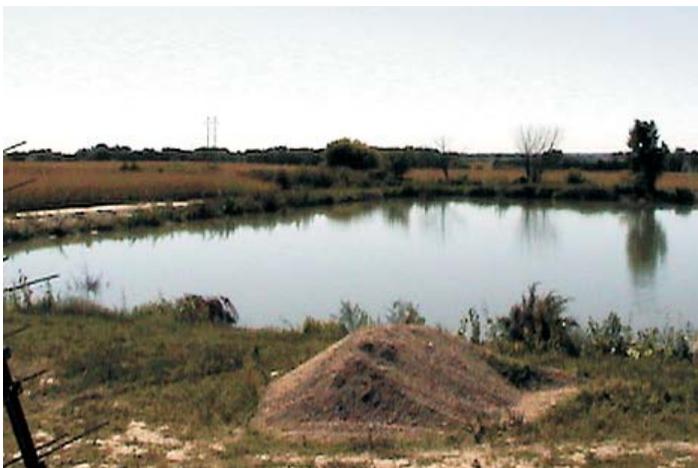
The wetland one year after construction.
