Climate and Land Use Consequences to 100-Year Flooding

Robert Roseen D.WRE, PE, PhD, Ann Scholz, PE, CPSWQ,
Thomas Ballestero, PhD, PE, PH, UNH Stormwater Center

Nebraska Post- Construction Stormwater Workshop
Lincoln, Nebraska
March 21, 2012

Lamprey River 100 Year Flood Risk Project

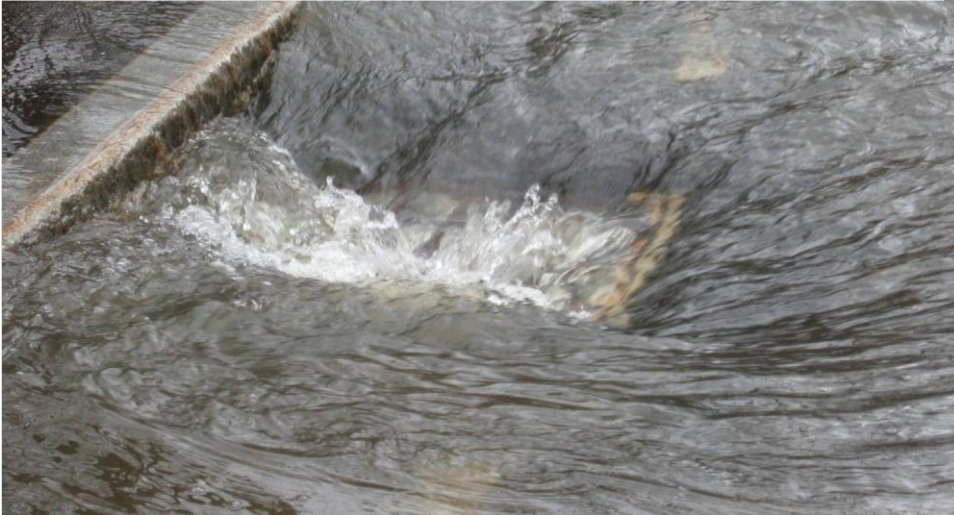
15 Highest Events – Peak Recorded Discharges on Lamprey River

Of 15 largest events since 1934:
8 have occurred in last 25 years
5 have occurred in last 15 years
3 have occurred in last 5 years

FIS: 7300 cfs = 100-Yr Flood Flow
